**LIQUEFACTION EFFECTS AND ASSOCIATED DAMAGE
AT THE PORT OF WELLINGTON**

Version 1.0: 22 JUNE 2017

This is QuakeCoRE publication number 0198 and UC Research Report 2017-8. The content is identical with Chapter 5 of GEER Report Number: GEER-053 and UC Research Report 2017-7.

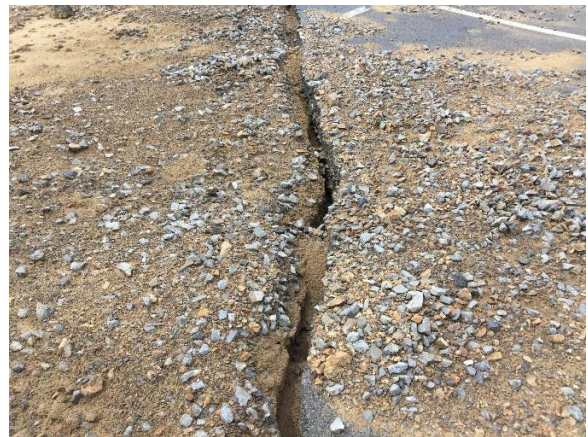
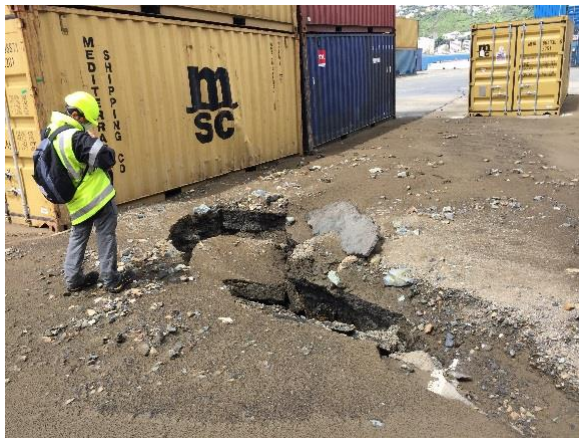
Figure 4.1: Gravelly ejecta at the Thorndon Container Terminal: (a) pavement cracking and ejected gravelly material (S41.280175°, E174.787308°); (b) characteristic gravel-size fractions of the ejecta with some cobbles observed in this area (S41.280206°, E174.787431°); (c) larger amount of gravelly ejecta around a cavity and collapsed pavement surface (S41.280361°, E174.789336°); (d) large volumes of ejecta observed along drainage lines (S41.278347°, E174.788069°, taken on 17NOV16).

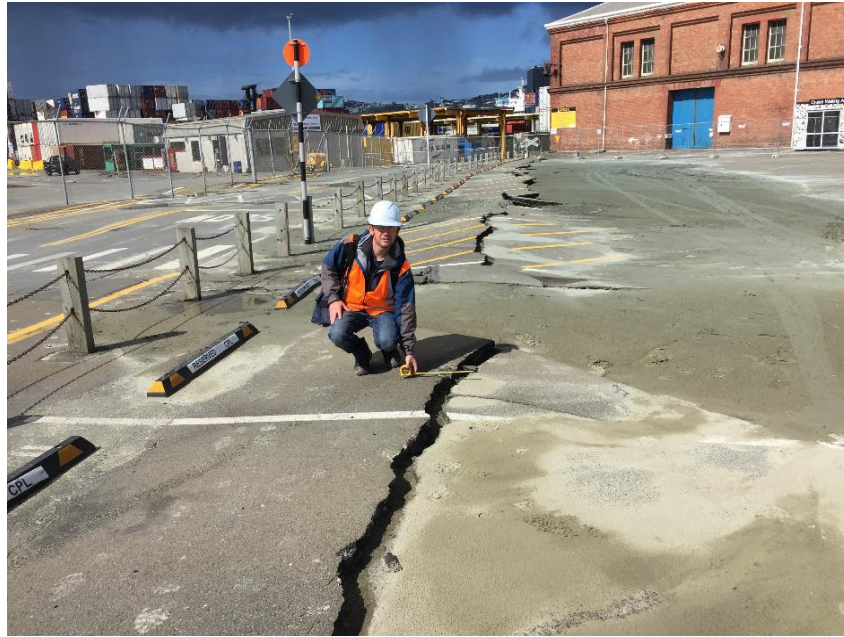
Figure 4.4: Sandy liquefaction ejecta behind buried mass concrete seawall looking southwest along seawall. On the right side of seawall: area of end-dumped quarry rock reclamation from 1904-1916 (Sample S2), left side of seawall: area of end-dumped quarry rock reclamation from 1970's Thorndon Reclamation. (S41.278454°, E174.785154°, taken on 17NOV16)

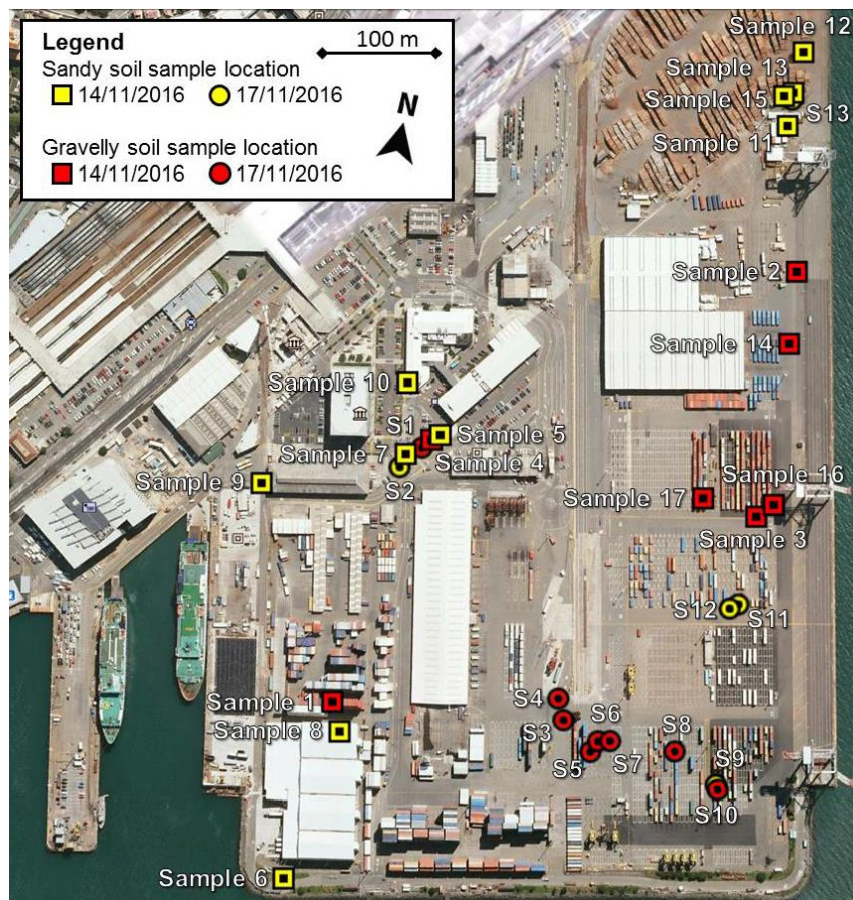
During the first field survey on 17 November, several ejecta samples were collected for index testing in the laboratory. Thirteen of those samples, indicated as S1 to S13 in this report, were collected from the locations shown in Figure 4.6. Sand liquefaction ejecta were observed at three different areas. These areas are: (1) in the Thorndon container stacking area at samples S11 and S12 (Figure 4.3), (2) immediately upland of the buried mass concrete seawall at sample S2 (Figure 4.4), and (3) in the log stacking area at sample S13 (Figure 4.5). Interestingly, only the log stacking area at S13 coincides with mapped area of sandy hydraulically-placed dredged fill (i.e., purple shaded area in Figure 2.2). Gravelly liquefaction ejecta were present over large portions of the Thorndon Reclamation and the Thorndon Reclamation Extension. This material is the end-dumped quarry rock referred to above as “common fill.” The remaining samples were collected from this material. Several photos of this gravelly liquefaction ejecta are shown in Figures 4.1 and 4.2.

Figure 4.6: Location of liquefaction ejecta samples collected on 14 November (Sample 1 to Sample 17), and 17 November (S1 to S13). (Base image from Google Earth™)

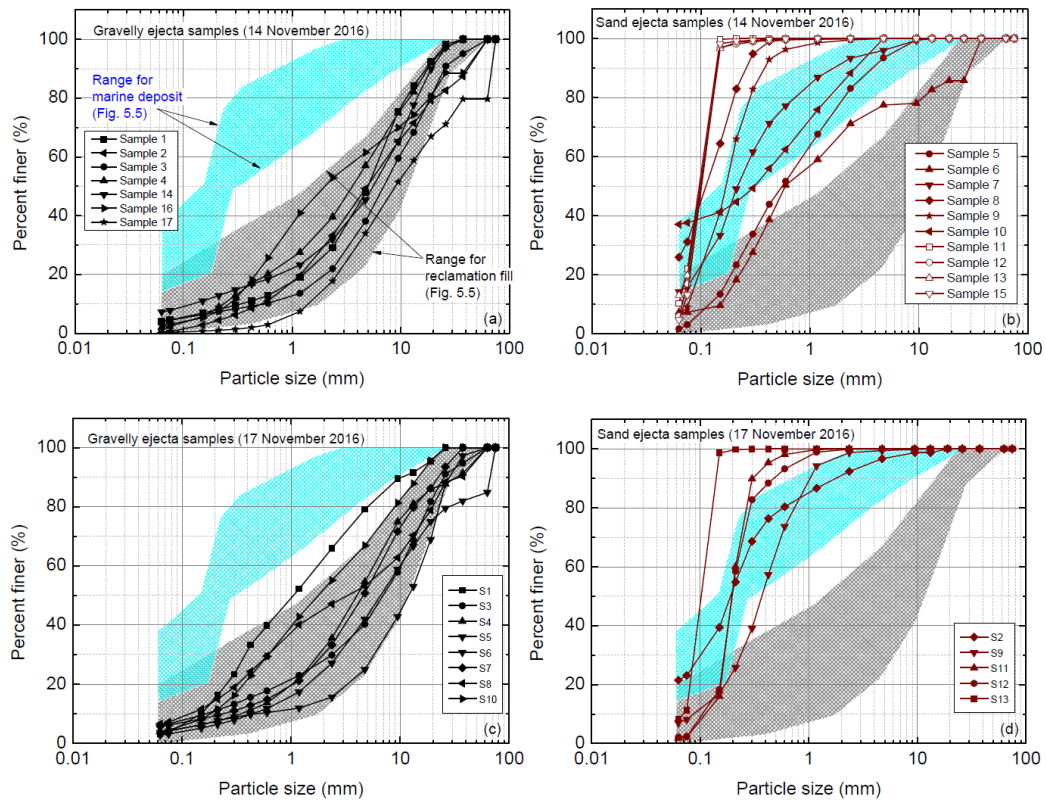
Grain size distribution curves obtained in the laboratory for the 13 ejecta samples are shown in Figures 4.7c and 4.7d where gravelly and sandy soils ejecta are shown respectively. The shaded areas in the background of these figures show the range of grain size distributions for the reclamation fill and marine deposit samples (collected from subsurface explorations) indicated in Figure 2.5. The grain-size curves of the gravel ejecta (solid lines in Figure 4.7c) are in good agreement with the grain-size distribution range of the gravelly soils of the

Thorndon reclamation (shaded zone in Figure 4.7c). Similarly, the grain-size distribution curves of the sand ejecta (solid lines in Figure 4.7d) are generally consistent with those of the marine deposits, except that ejecta samples show more uniform composition. Note that the hydraulically placed sandy fill was dredged from the original seabed, and hence has the same composition as marine deposits. The grading of the ejected soils is also consistent with the sand fractions of the fill material. Samples from the ejected soils were also collected from additional 15 locations (shown in Figure 4.6) by Tonkin+Taylor, on 14 November. Importantly, these samples were collected before the severe rainfall on 14-15 November (Greater Wellington Regional Council, 2017) that potentially washed out some of the fines fractions of the ejected soils. Grain size distribution curves of the gravelly samples and sandy samples collected on 14 November are shown in Figures 4.7a and 4.7b in the same fashion as Figures 4.7c and 4.7d. By and large, both gravelly samples (solid lines in Figure 4.7a) and sandy samples (solid lines in Figure 4.7b) are in good agreement with the respective range of grain-size distribution curves obtained from borehole samples (shaded areas). Tables 4.1.a and 4.1b summarize the field visual classification (Tonkin+Taylor, private communication), the mean grain size (D_{50}), and fines content (F_C) obtained from the laboratory tests on the samples collected on 14 November (Sample 1 to 15) and 17 November (S1 to S13) respectively.

Figure 4.7: Grain size distribution for liquefaction ejecta samples collected on reclaimed land from (a) gravelly quarry rock fill on 14 November, and (b) sandy fill on 14 November, (c) gravelly quarry rock fill on 17 November, and (d) sandy fill on 17 November. Shaded regions show ranges of grain size for marine deposits and reclamation fill collected from subsurface explorations (plotted in Figure 2.5).

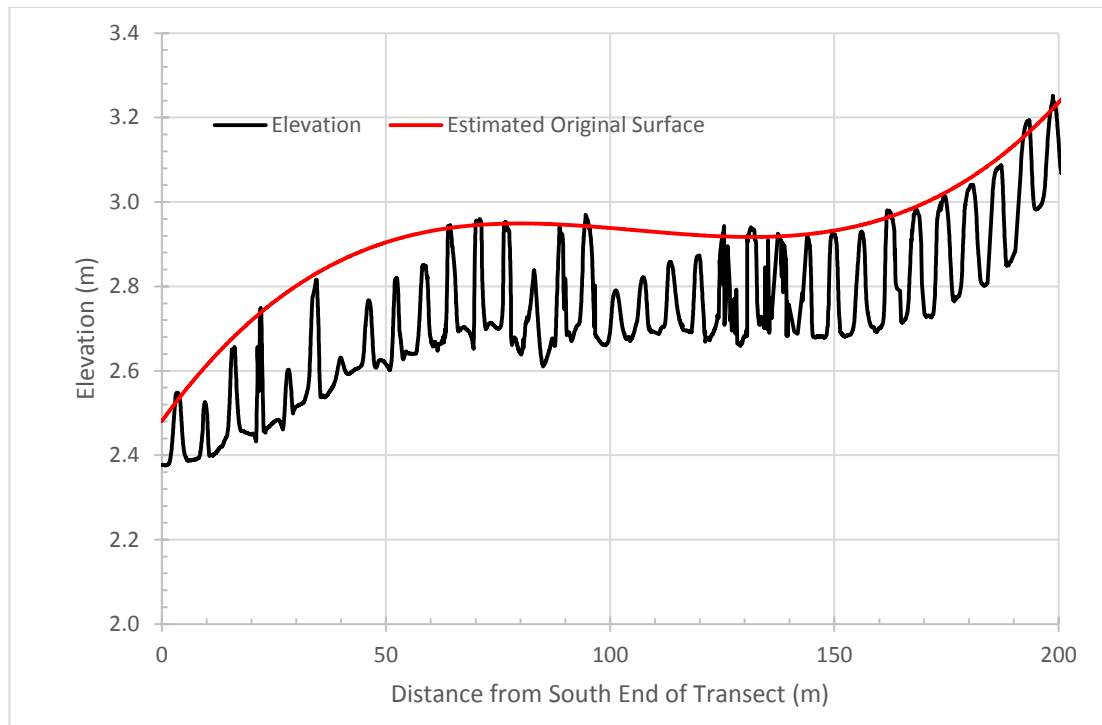
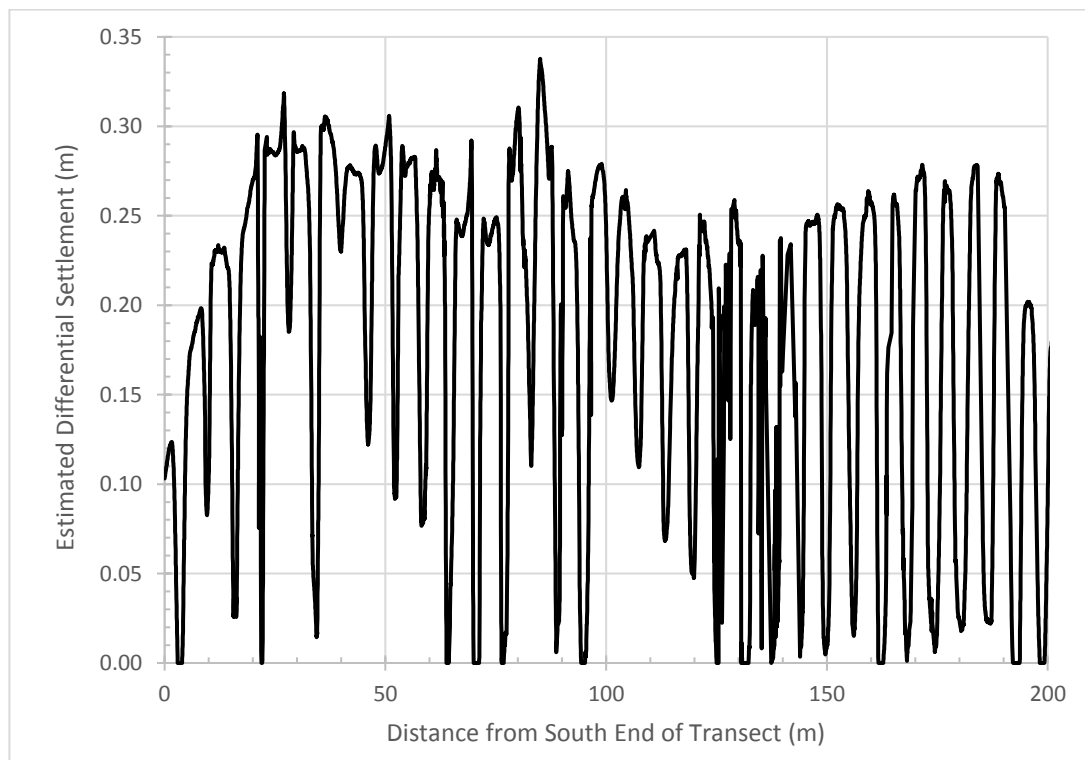
Figure 5.4 shows a cross-section obtained on the west edge of the road immediately west of Building S37. The peaks are locations of the buried piles and the lower portions are settlement of the pavement surface around those piles. In absence of detailed survey data prior to the event, the original surface was estimated by fitting a 3rd order polynomial ($R^2 = 0.99$) to the tops of piles with higher elevations in the local area. Given this assumption, the differential settlement calculations (Figure 5.4(b)) do not account for any settlement of those piles which may have occurred given that some of the piles in that sequence appear to have settled. Regardless, the trends are reasonably consistent with the values shown in Figure 4.8.

Figure 5.4: (a) Post-earthquake elevations for transect (LT1) along west side of roadway west of S37; the red line represents the estimated pre-elevation surface. (b) Estimated settlements. (Distance 0 is approximately 15 m south of the south wall of Building S37 and the 200 m transect runs to about 3 m north of the north wall of Building S37).

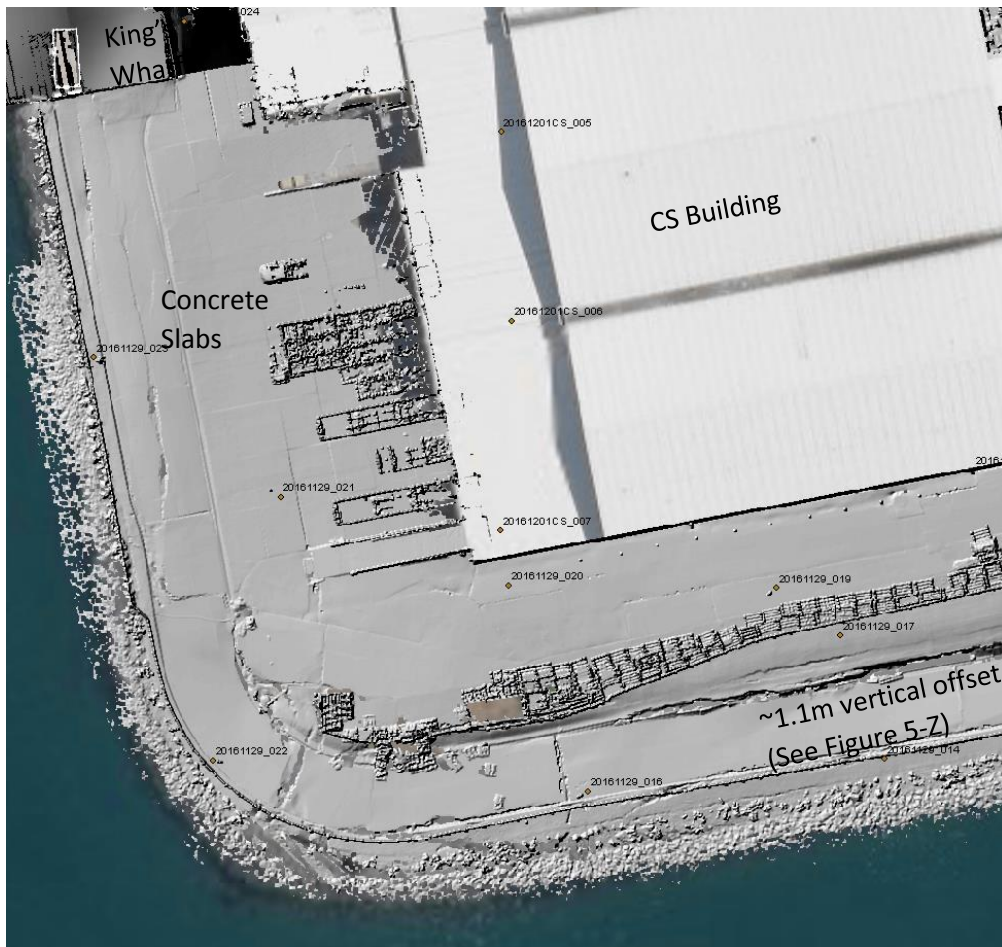
Several TLS observations were obtained throughout the area surrounding the CS building at the southwest corner of the port, which experienced widespread liquefaction-induced ground deformations. The LiDAR DEM was converted to a hillshade to enhance visualization of cracks and other features in this area (Figure 5.5). The hillshade visualization highlights discontinuities in the data and provides detailed information on cracking patterns observed. In addition, differential settlement between the concrete slabs between the road and cold store building are apparent.

Figure 5.5: Example hillshade for the SW corner of the port, south of the CS building. This dataset was coarsely cleaned and still contains several artifacts from railing and metal racks.

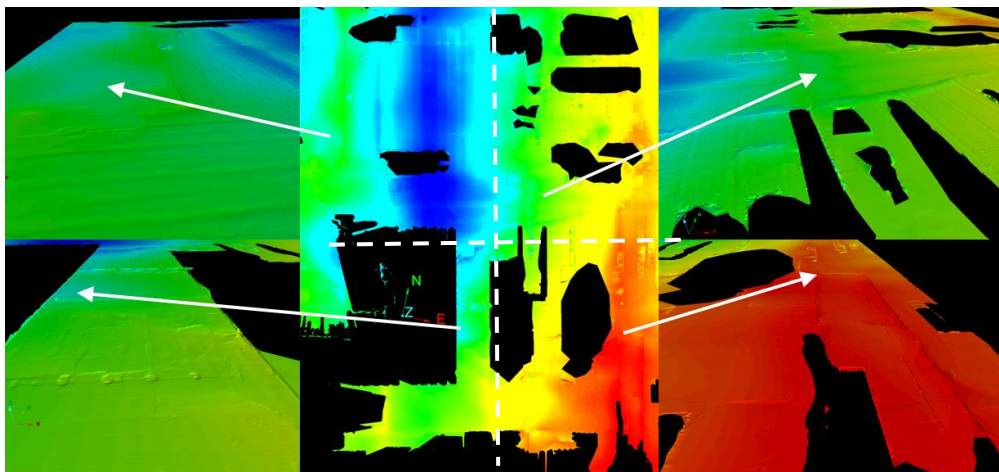
Figure 5.6: Example DEMs of the southeast portion of the port (next to, but not including Thornton Wharf) highlighting various liquefaction settlements and accretion of materials. Elevation ranges from 2.05 m (Red) to 3.80 m (Blue). The center image is a plan view, and the other images are perspective views to show detail.

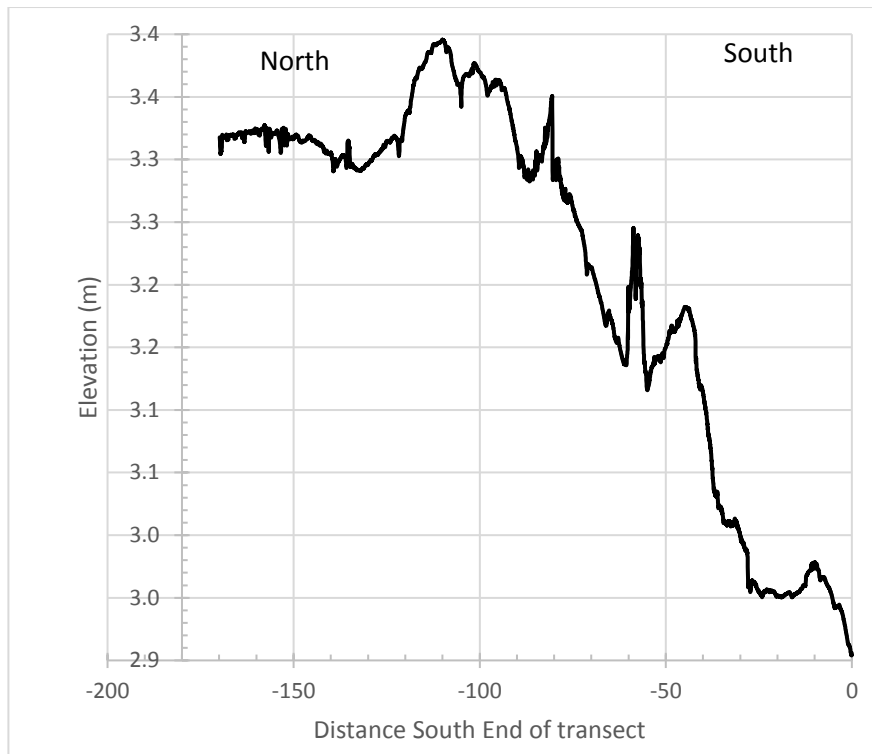
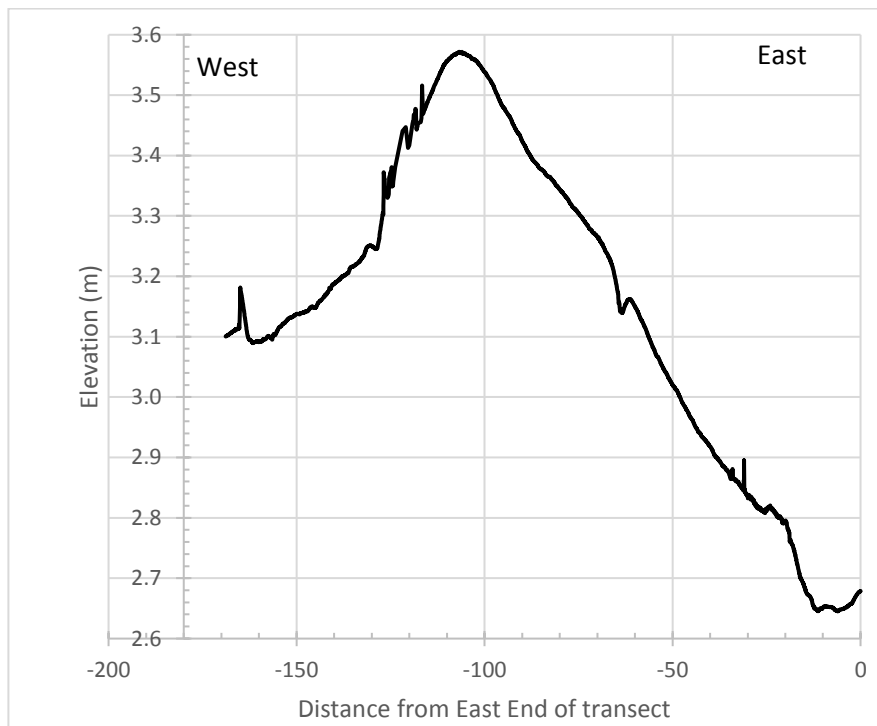
Figure 5.7: Cross sections across the southeast portion of the Thorndon Reclamation: (a) North South Transect LT2, and (b) East-West Transect LT3. Locations of transects are identified in Figure 5.2.

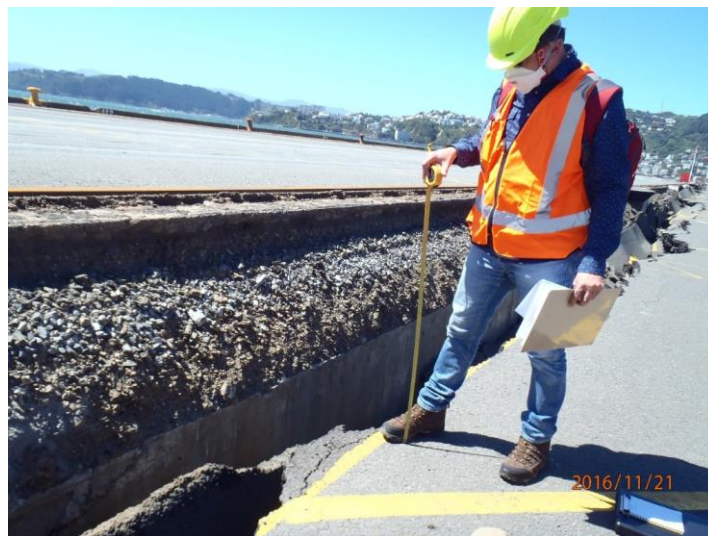
of it are listed in Table 6.1 and indicated in Figure 4.9. These measured values range from 200 to 500 mm. Ground settlement immediately inland of the bulkhead, relative to the wharf deck, was estimated to be 600 mm. Figures 6.3 and 6.4 show the vertical offset created between the pile supported wharf and reclaimed fill behind the wharf.

Figure 6.3: Looking south along Thorndon Wharf bulkhead at approximately STA 240. Approximately 600 mm of ground settlement measured relative to pile-supported wharf. (S41.278250° E174.789205°, taken at 1124 hrs on 21NOV16)

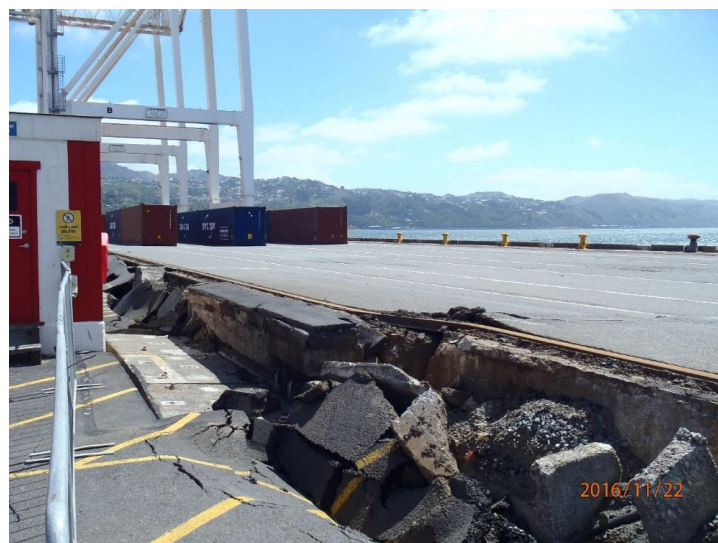
Figure 6.4: Looking north along Thorndon Wharf bulkhead at approximately STA 280. Approximately 600 mm of ground settlement measured relative to pile-supported wharf. (S41.277743° E174.789236°, taken on 22NOV16)

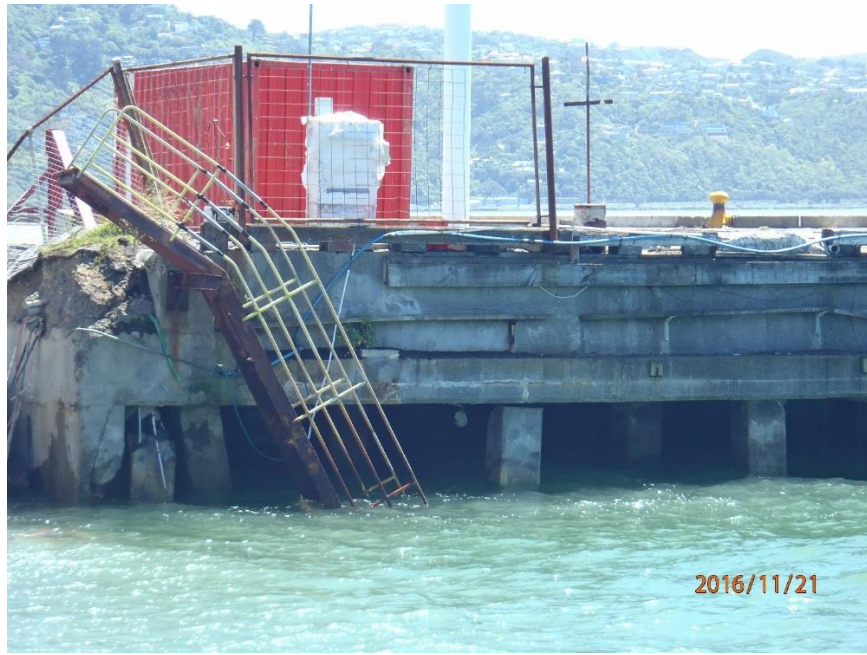
The QuakeCoRE-GEER team was informed that concrete piles had been sheared near the pile cap (from a boat survey by others; T+T (2016) private communication). From the south side of the port, the QuakeCoRE-GEER team did observe a vertical bulkhead pile sheared just below the pile cap (Figure 6.5a). During a site visit in May 2017, the team observed that the bulkhead piles (both plumb and battered) near the north end of the Thorndon Reclamation were damaged immediately below the deck (Figure 6.5b). Cardno performed an aerial survey of the port that captured vertical settlement and lateral movement, which is shown in Figure 6.6. The magnitude of lateral spreading displacement and settlement measured by Cardno are generally consistent with those measured by the QuakeCoRE-GEER team, which are provided in this report.

Figure 6.5: (a) Looking north towards the southern end of Thorndon Wharf. The vertical bulkhead pile is sheared just below the pile cap. QuakeCoRE-GEER team was informed that many piles in this area were sheared near the pile cap (from a boat survey by others; T+T (2016) private communication) (S41.280219° E174.789974°, taken at 1152 hrs on 22NOV16) (b) Looking north under the Thorndon Wharf bulkhead toward damaged plumb and battered bulkhead piles. (S41.277312° E174.789081°, taken at 13:38 hrs on 08MAY17)

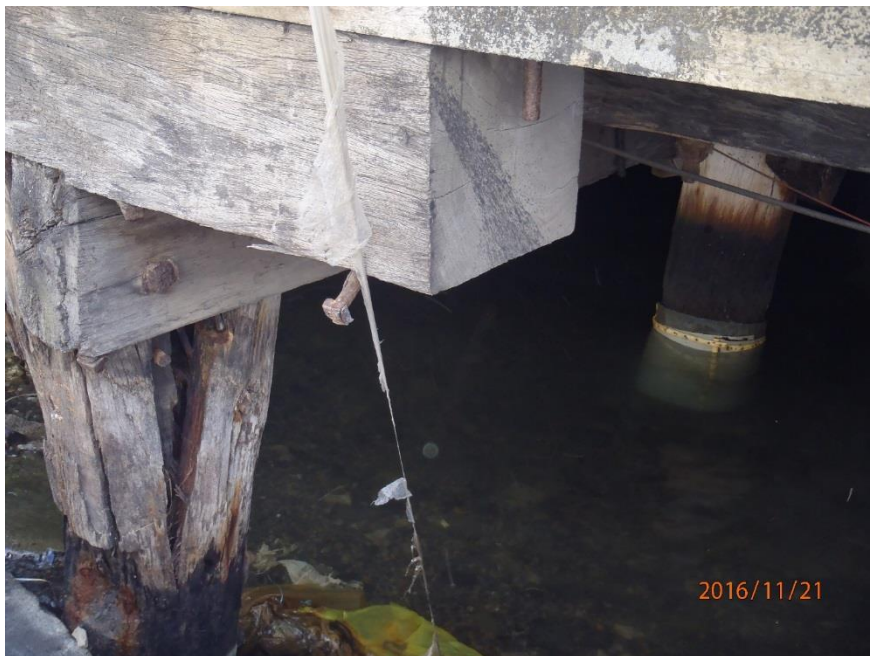
The inland timber piles split due to seaward (westward) lateral movement of the deck relative to the piles (Figure 6.11). Westward movement of the structure is visible in Figure 6.12, in which the southern row of piles is shown leaning to the west. Some vertical curvature of the wharf deck can be observed in the LiDAR DEM (Figure 6.13) and associated cross section in Figure 6.14. Differential settlement between the wharf and adjacent ground range from 475 mm to 630 mm as measured from the LiDAR-derived DEM. The wharf deck exhibits significant concavity (downward) as observed in the cross section plotted on Figure 6.14.

Figure 6.11: Looking under King's Wharf at an inland bulkhead pile. Timber pile is split from lateral movement (seaward/westward) of the deck relative to the pile. (S41.280900° E174.784375°, taken at 1412 hrs on 21NOV16)

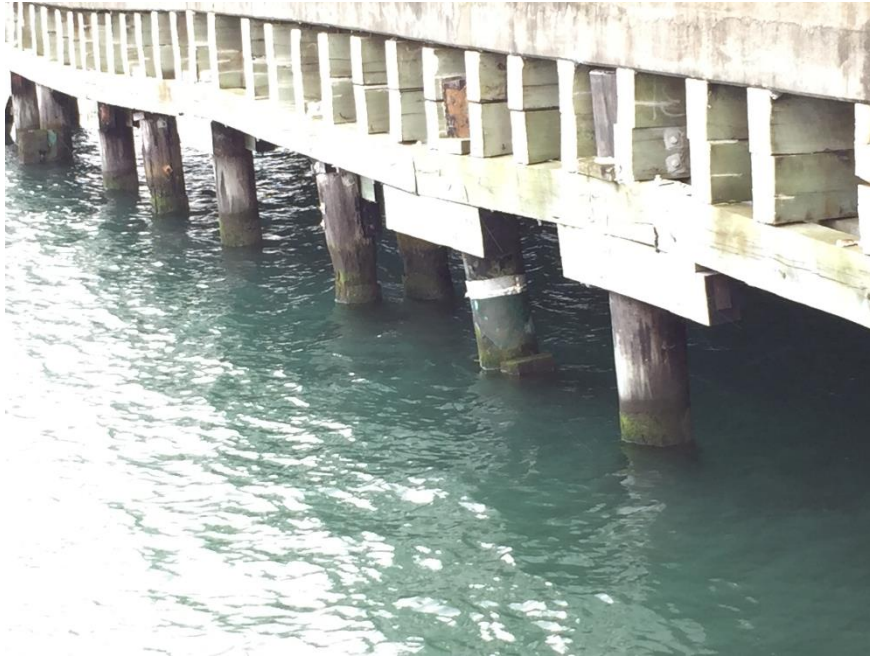
Figure 6.12: Looking west along southern end of King's Wharf. Westward tilt of piles is visible. (S41.281281° W174.784097°, taken on 17NOV16)

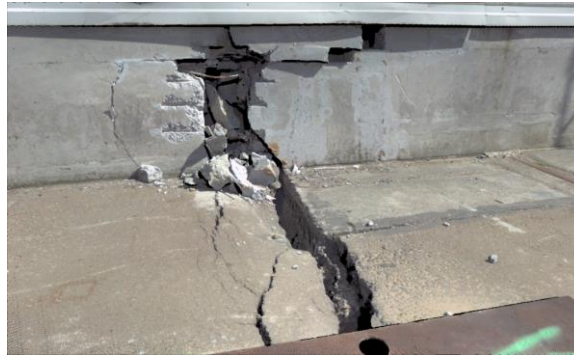
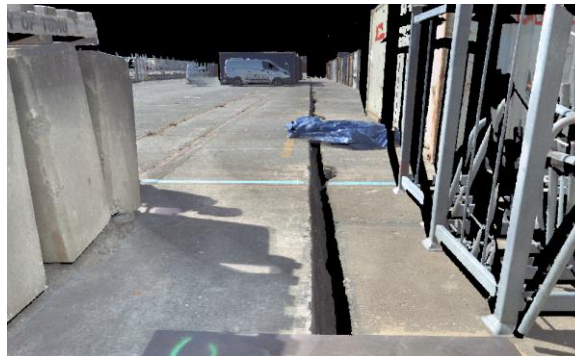
Figure 7.13 documents significant cracking resulting in exposure of rebar in the foundation of the CS building on the north side from a LiDAR scan. Figure 7.13(a) looks south at the north wall of the CS building while Figure 7.13(b) shows the same crack running northward. The width of this crack is fairly consistent at 200 mm for much of the length as was observed in the LiDAR scan; however, it widens to 500 mm at some locations in the north and narrows to approximately 180 mm closer to the building (minimum width is 150 mm).

Figure 7.13: (a) Significant damage and cracking observed in the LiDAR scan data at the north end of the CS building. (b) The same crack extending northward across the port.

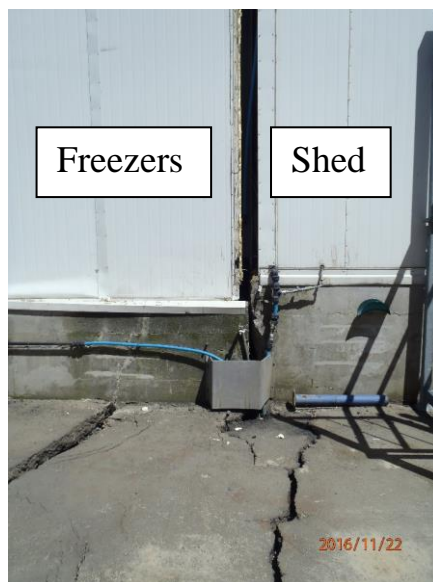
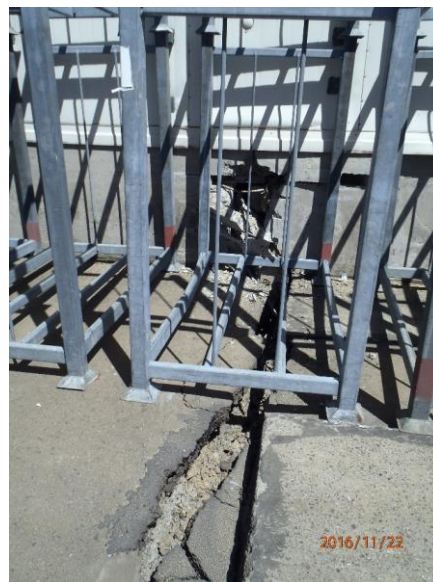
Figure 7.14: Cracks along the exterior north wall of CS building: (a) 150 mm of separation between Shed and Freezers (i.e., westward/seaward movement of the Shed relative to the Freezers), (S41.280584° E174.784705°, taken at 1445 hrs on 22NOV16), and (b) 180 mm crack in the shed from westward lateral spreading (also shown in Figure 7.13b). (S41.280607° E174.784533°, taken at 1444 hrs on 22NOV16)

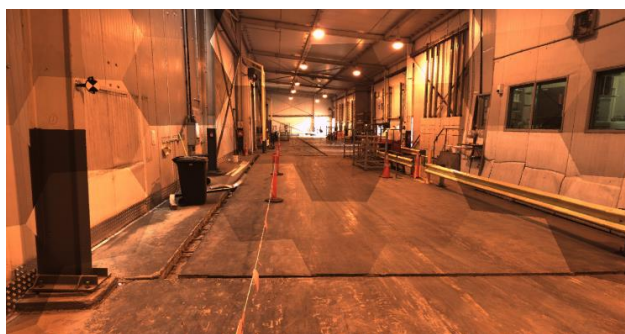
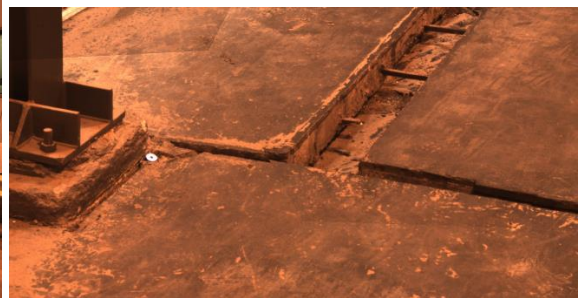
Figure 7.18: Example panoramic imagery co-acquired with the laser scans: (a) overview, and (b) close-up of floor separation in the CS building. The larger crack measures 230 mm in width and the smaller crack measures 75 mm in width.

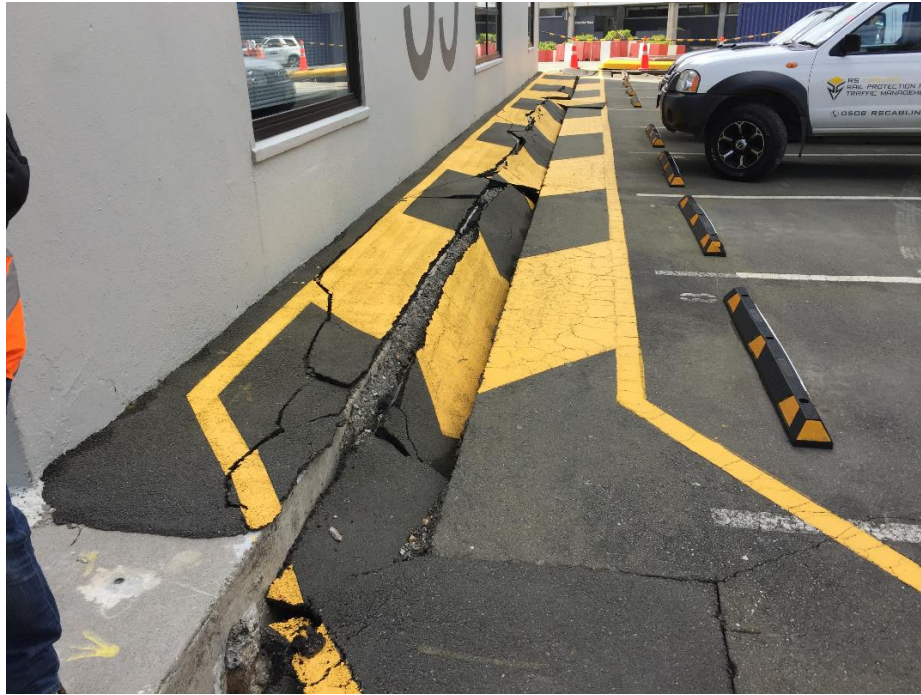
Figure 7.23: Looking southeast along southwest wall of S39. Fill settled approximately 190 mm relative to pile-supported building at the northwest corner of the building (shown on lower left corner of photo), and magnitude of settlement decreased south-eastward along this wall. (S41.277994°, E174.785467°, taken on 17NOV16)

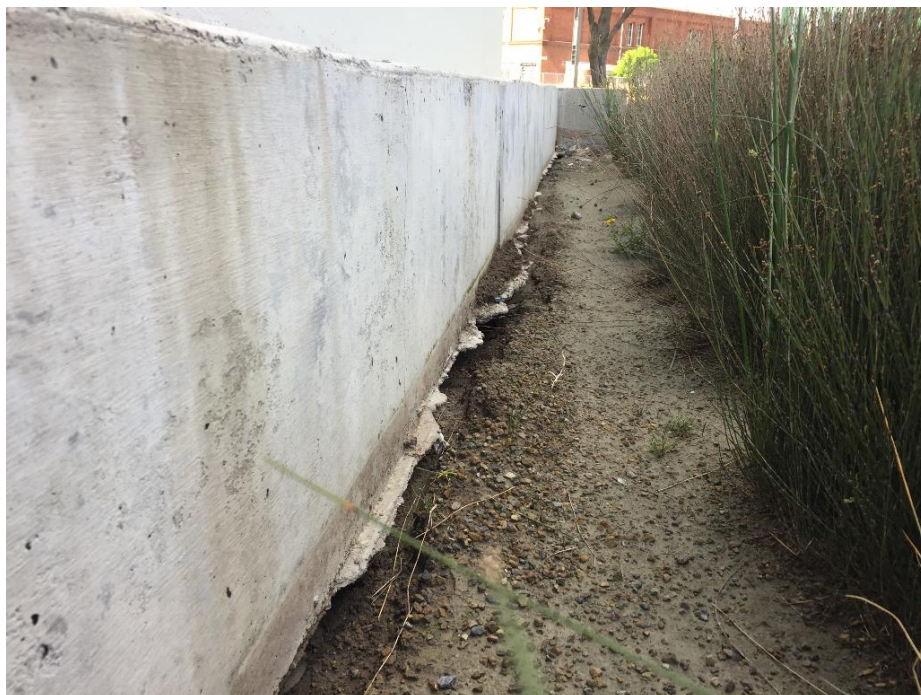
Figure 7.24: Looking southwest along northwest wall of S39. Fill settled 50-100 mm relative to pile-supported building. (S41.277882°, E174.785371°, taken on 17NOV16)

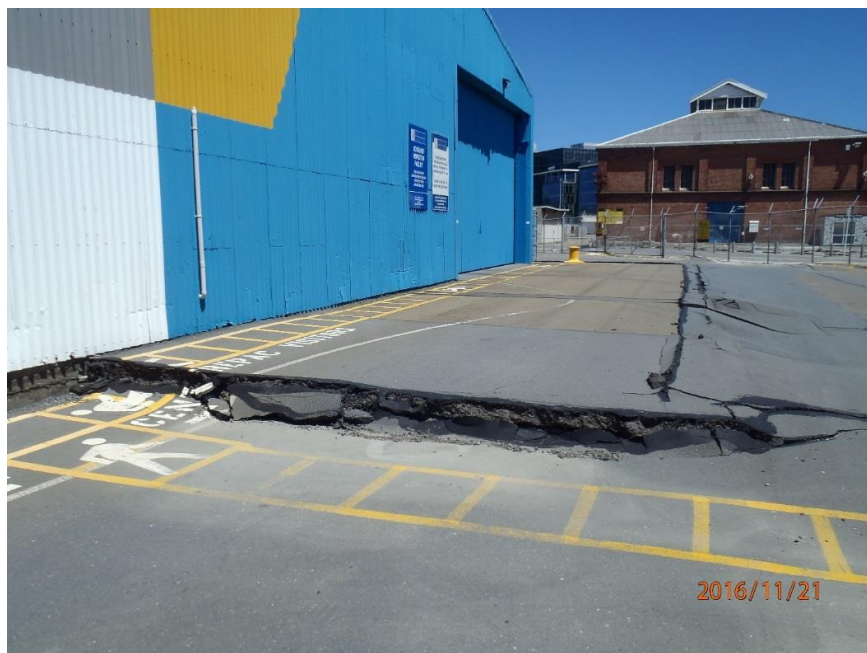
Figure 7.27: Looking west across north wall of Building S37. Approximately 400mm of differential settlement between ground and deck of buried, pile-supported Pipitea Wharf that supports the western side of the shed. (S41.278571°, E174.785632°, taken at 1227 hrs on 21NOV16)

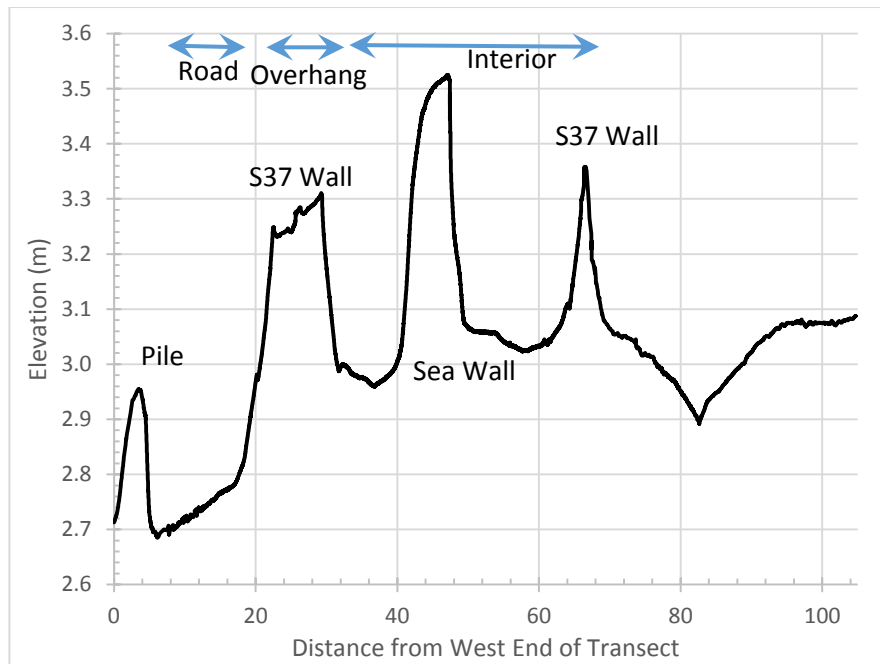
Figure 7.28: East-west cross-section (LT6) through the northern part of Building S37. Note the significant vertical exaggeration.

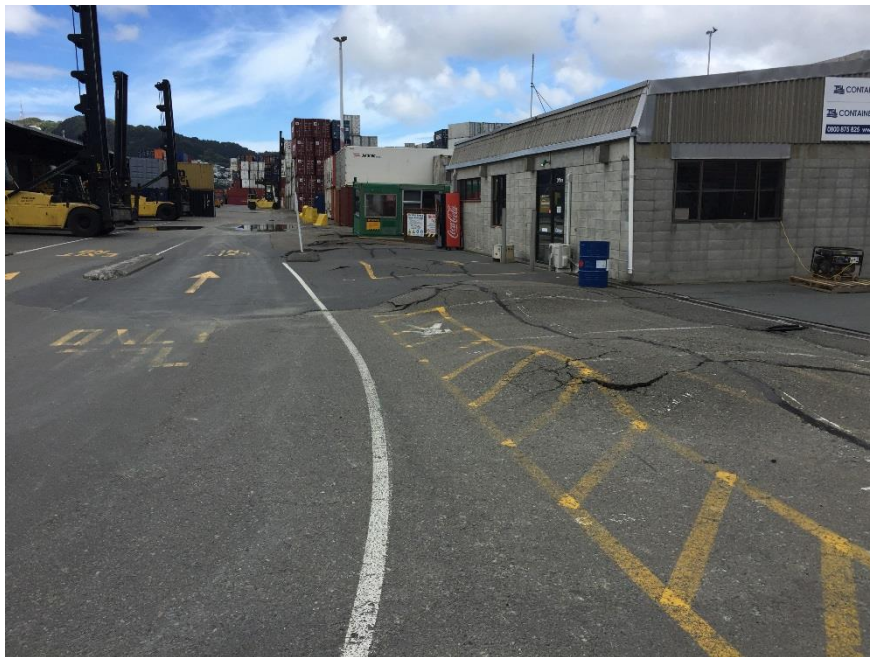
The western half of the S37 building is founded on the deck of the buried, partially demolished pile-supported old Pipitea Wharf, and the east wall of the building is supported on piles. The precast seawall that formerly ran along the bulkhead of the Pipitea Wharf is now buried and runs south-to-north through about the centerline of the building. The ground floor slab not supported either on piles, the old wharf deck, or the precast seawall settled up to 550 mm relative to these structures (Figures 7.26 and 7.27; and 7.28 from LiDAR scan). The ground settled approximately 375 mm relative to the building along the exterior of the east wall of the S37 building (Figure 7.30). Figure 7.28 plots elevations from transect LT6 (see Figure 5.2 for transect location) through the S37 Building, and Figure 7.29 provides a 3D view of the building interior from a LiDAR scan. Approximately 16 m west of the western wall of the S37 building, a buried row of piles from the old Pipitea Wharf protruded from the ground as the surrounding fill settled approximately 300 mm relative to the piles (Figure 7.31).

Figure 7.31: Looking south along western-most row of piles from partially demolished and buried Pipitea Wharf, which is approximately 16 m west of Building S37. Fill settled 300 mm relative to embedded piles (S41.278798°, E174.785186°, taken on 17NOV16). A cross section (LT1) is shown in Figure 5.4.

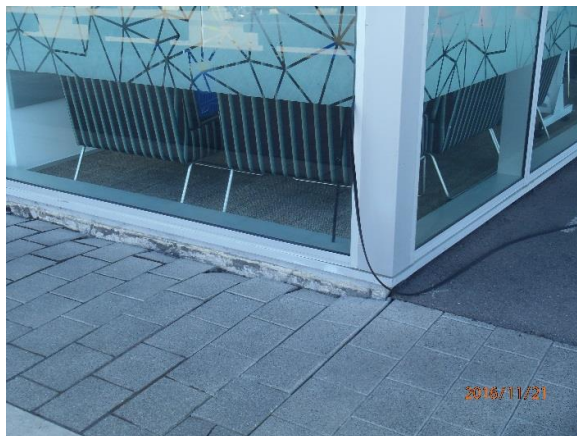
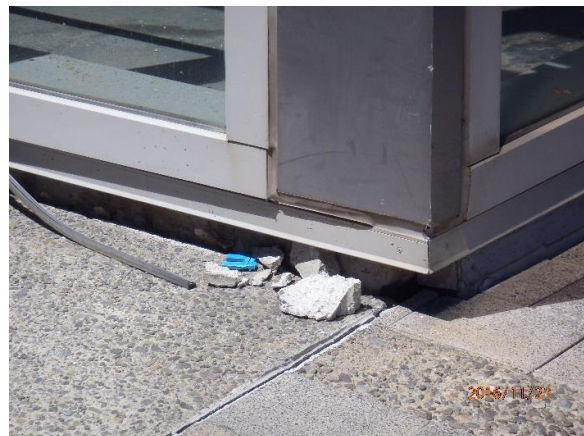
The B building is supported on piles with stone column ground improvement performed over the southeastern (seaward) half of the building footprint. The surrounding ground settled approximately 50 to 90 mm uniformly relative to the building (Figure 7.37). No other significant movements were observed.

Figure 7.37: Ground settlement relative to the pile-supported B building at: (a) the southwest corner of the building with ground improvement (S41.279767°, E174.782100°), and (b) northwest corner of the building without ground improvement (S41.279419°, E174.781443°). (taken at 1350 hrs on 21NOV16)
